ASSESSMENT OF
CLOSED WASTE DISPOSAL SITES
PHASE III
INVESTIGATION AND MONITORING
NEWTON LANDFILL SITE, CAMBRIDGE

AUGUST 1989

Report prepared for:
Waste Site Evaluation Unit
Waste Management Branch

Report prepared by:
M.M. Dillon Limited

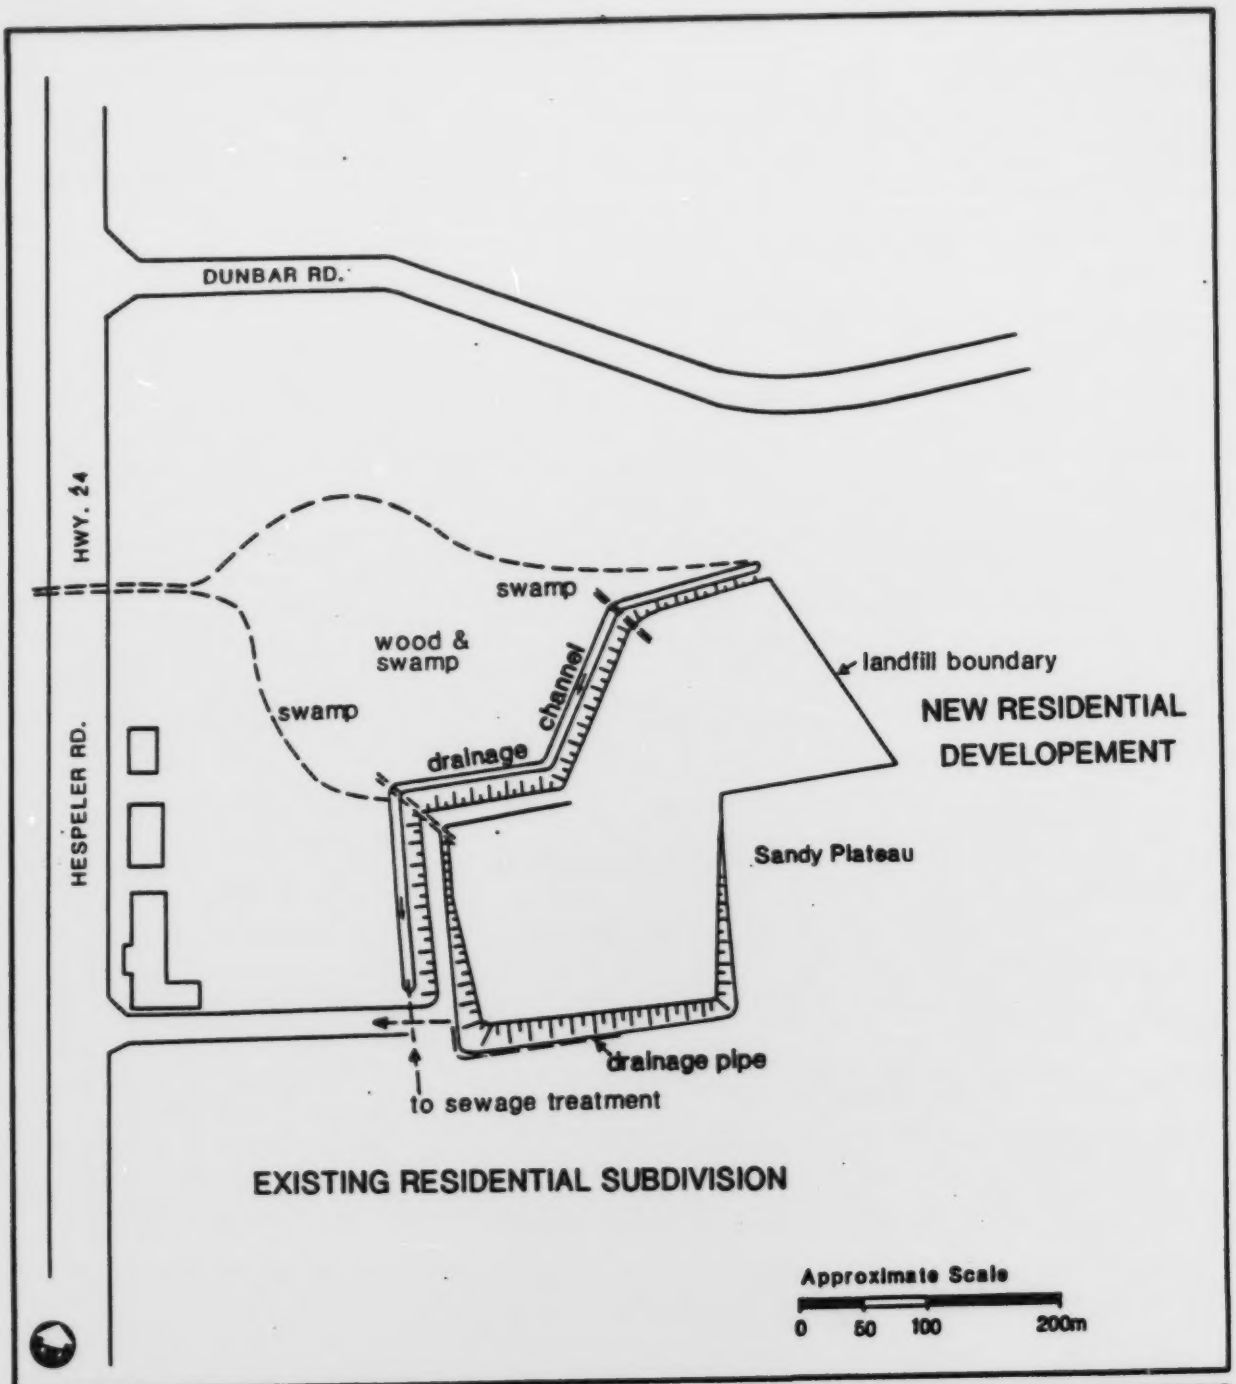
Figure 2

A leachate collector system was built by the City of Cambridge prior to 1977 as a result of off-site leachate migration. This system is a rudimentary drainage channel which intersects the shallow ground water table (Figure 2). The channel is located along the northern and western edges of the landfill site. The channel diverts water into a catchbasin near the entrance to the landfill site which subsequently feeds the leachate into the local sanitary sewer system.

report completed in 1979 concerned itself with new development north and west of the landfill site. This report concluded that the depression (swamp) area northwest of the landfill (Figure 2) produced methane gas, and gas control measures should be considered for future and present structures along Highway 24 south of Dunbar Road.

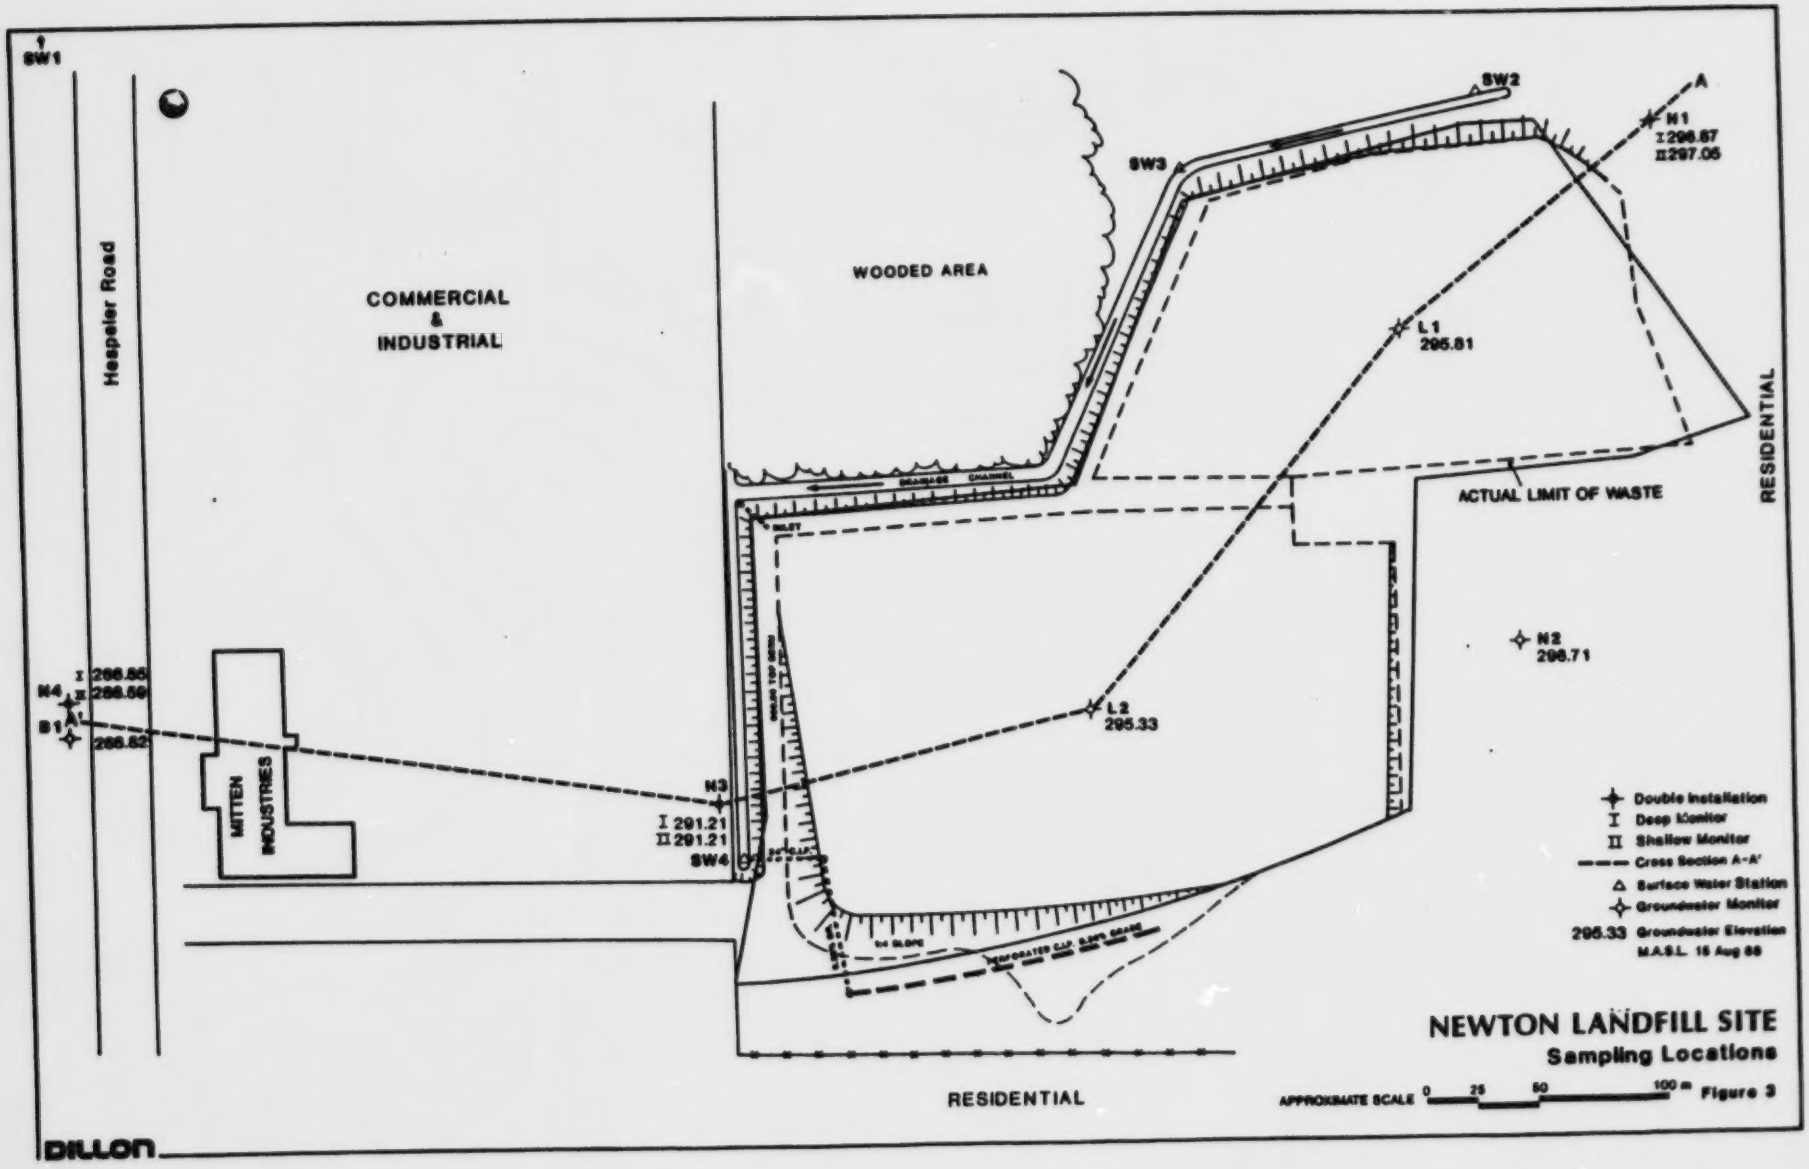
The refuse was found to extend to depths of 5.5 m in borehole L1 and 8.2 m in borehole L2. This consisted predominantly of domestic waste such as cloth, rubber tires, paper, etc. In addition, concrete blocks and metal objects similar to car parts were encountered during drilling. The approximate areal extent of the refuse is shown on Figure 3.

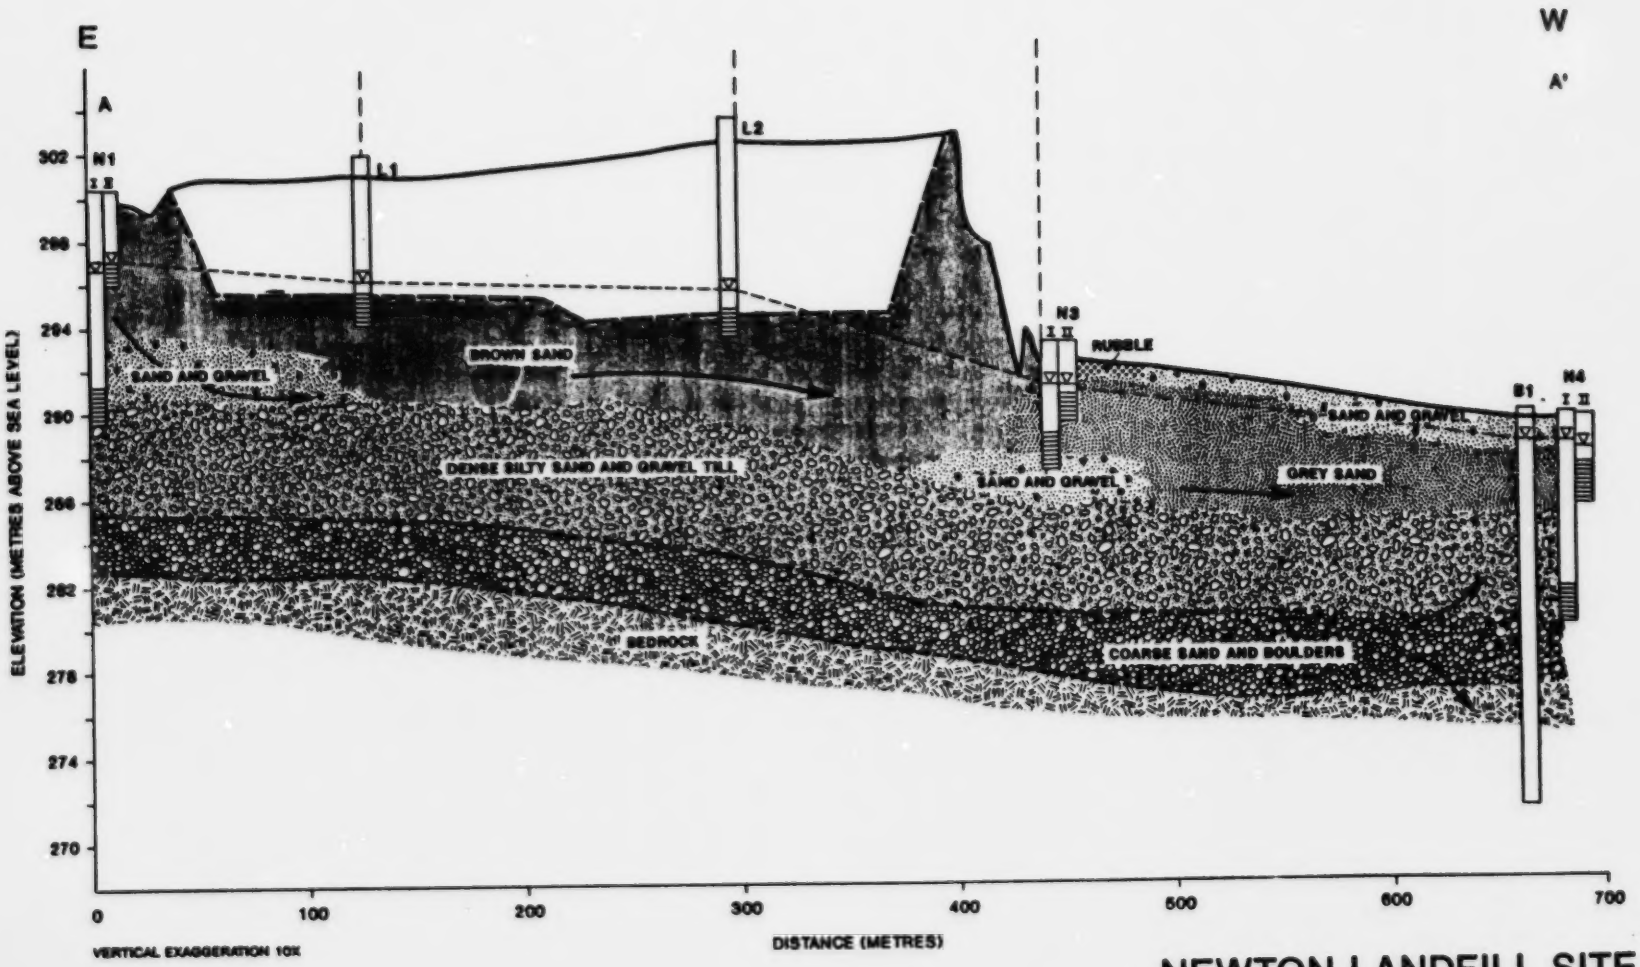
The two boreholes located on the west side of Highway 24 penetrated 3.5 m of grey fine grained sand overlain by 1 m of sand and gravel. At this location, a very dense silty sand and gravel till unit 4.8 m thick, was encountered beneath the grey sand. This unit, although found below the water table, did not produce water during drilling. The till is underlain by 3.1 m of coarse sand, gravel and boulders (see Figure 4).

west of Highway 24 indicate a downward gradient of 0.033 between the coarse overburden and the bedrock. These gradients suggest that the ground water in the deep overburden aquifer is under confined conditions. Based on the gradients observed at the site, ground water flow directions are schematically illustrated on Figure 4.

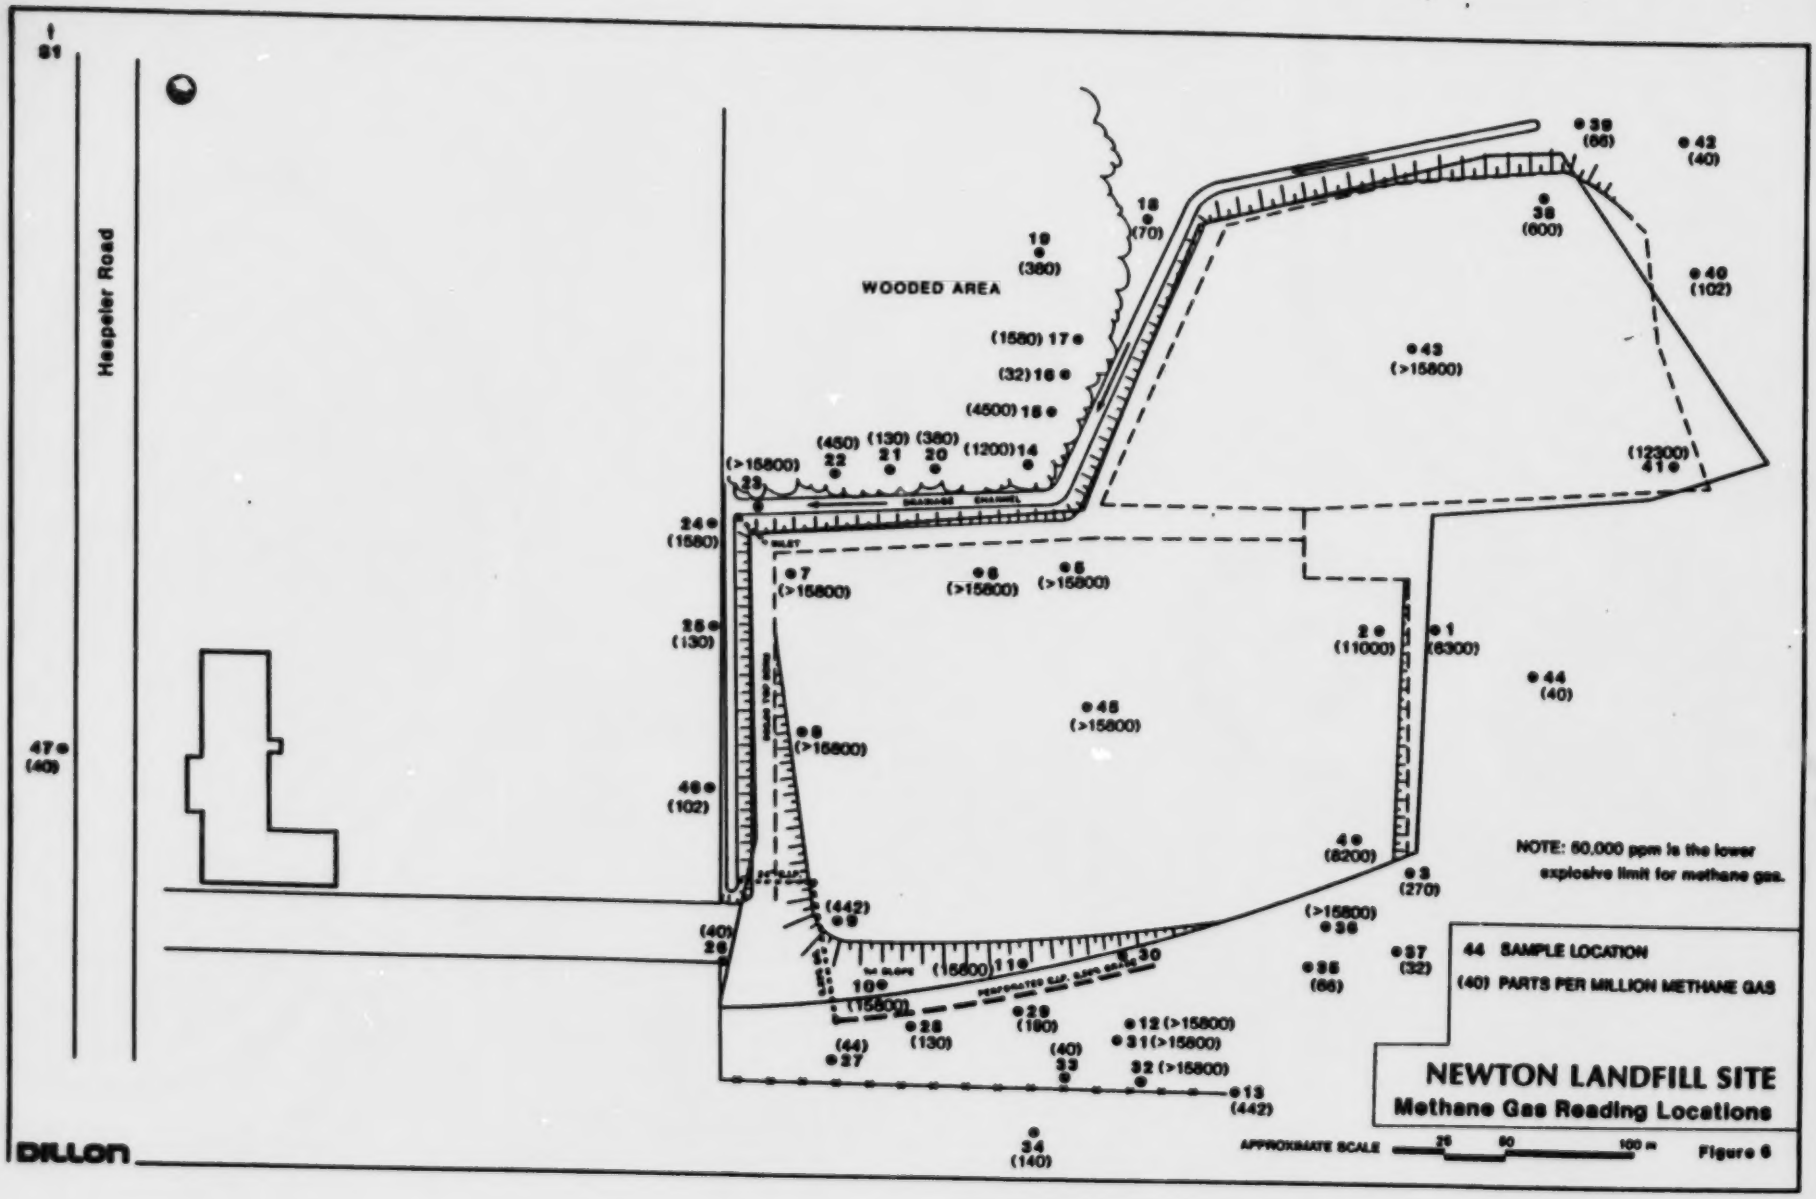
Location	Methane (ppm)	% LEL*	Depth (m)
1	6 300	13	1.0
2	11 000	22	1.0
3	270	0.5	1.0
4	8 200	16	1.0
5	>15 800	>31	0.8
6	>15 000	>31	0.6
7	>15 800	>31	0.5
8	>15 800	>31	0.8
9	442	0.8	0.6
10	>15 800	>31	0.4
11	>15 800	>31	0.4
12	>15 800	>31	1.0
14	1 200	2.4	1.3
15	9 500	19	1.3
16	32	0.06	1.3
17	1 580	3.1	1.3
18	70	.1	1.3
19	380	0.7	1.3
20	380	0.7	0.4
21	130	0.2	0.5
22	450	0.8	0.80
23	>15 800	>31	Surface
24	1 580	3.1	0.40
25	130	0.2	0.30
26	40	0.08	1.00
27	44	0.08	1.00
28	130	0.2	1.00
29	190	0.42	1.00
30	220	0.44	1.00
31	>15 800	>31	1.00
32	>15 800	>31	1.00
33	40	0.08	1.00
34	140	0.28	1.00
35	66	0.13	1.00
36	>15 800	>31	0.60
37	32	0.06	0.80
38	600	1	0.80
39	66	0.1	0.80
40	102	0.2	1.20
41	12 300	25	1.20
42 (N1)	40	0.08	1.0 - 3.1
43 (L1)	>15 800	>31	1.0 - 3.1
44 (N2)	40	0.08	1.0 - 3.1
45 (L2)	>15 800	>31	1.0 - 3.1
46 (N3)	102	0.2	1.0 - 3.1
47 (N4)	40	0.08	1.0 - 3.1

The Newton Landfill site is an active producer of methane gas at concentrations in excess of 15 800 ppm (>30% of the lower explosive concentration). The sampling program indicated significant lateral migration of methane to the south. Under frozen ground conditions, when vertical venting through the permeable sand is no longer possible, lateral migration will

accelerate. Therefore, the southward migration of methane represents a potential hazard to the newly developed residential area adjacent the site.

- A methane monitoring program should be implemented at the landfill in coordination with the ongoing program developed by the City of Cambridge. The focus of this program should be on the southern side, to assess the efficiency of the existing passive venting system, and to provide forewarning of hazardous methane migration to the residences.
